Accelerating The Readiness of The H2 Plant Unit and Maintaining the Quantity of HCU Valuable Product During Repairs to The Radiant Tube Reformer Leak Using a New Radiant Tube Reformer Plugging Method at PT Pertamina Patra Niaga Refinery Unit II Dumai

PT Pertamina Patra Niaga Refinery Unit II Dumai, Indonesia

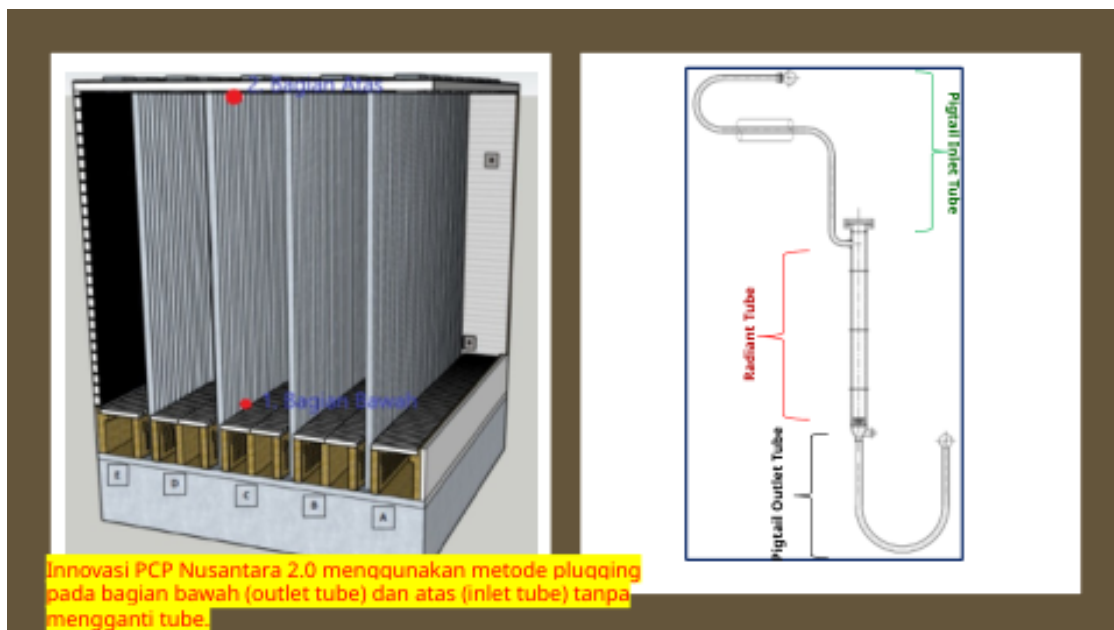
The innovation isolated the failed radiant tube instead of replacing it. The damaged tube section was cut, a plug was inserted and permanently welded at the lower side, and the same isolation was performed at the upper side. Ceramic fiber insulation was then installed to retain heat and secure the repaired area.

Figure 2. Concept illustration of the plugging method applied to the inlet and outlet sides of the failed radiant tube.

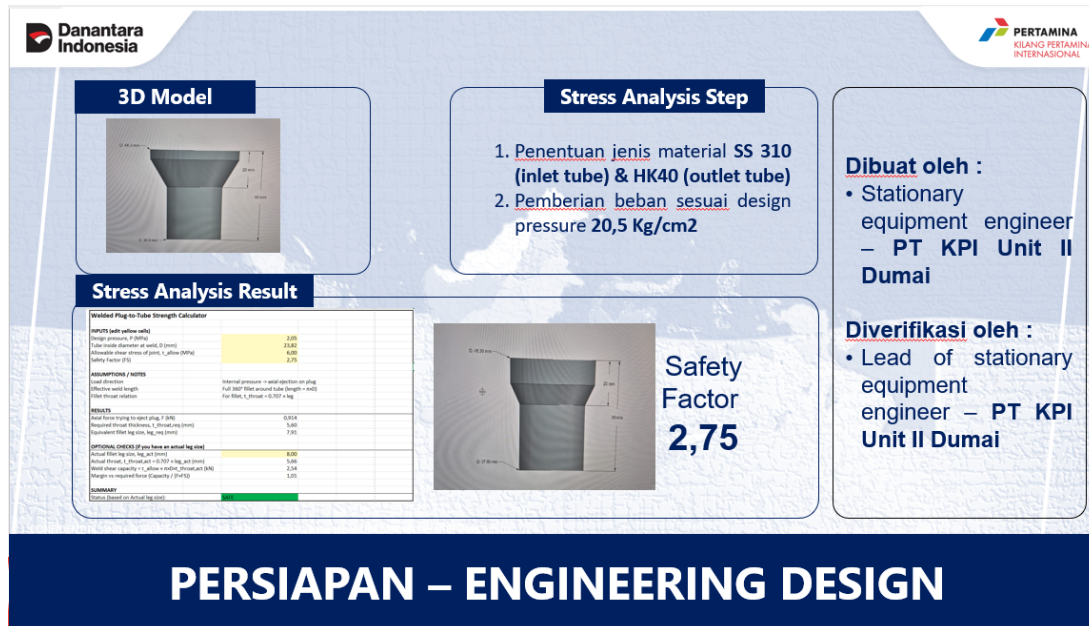
- 3D model development of the plug concept.
- Stress analysis setup using the selected geometry and imposed design loading.
- Material selection using SS 310 for the inlet side and HK40 for the outlet side.
- Verification at the operating/design pressure envelope up to 20.5 kg/cm².

Figure 3. Engineering preparation slide showing 3D modeling, stress-analysis workflow, material selection, and reported safety factor.

The reported stress-analysis result gave a safety factor of 2.75 for the design basis presented on the slide. This exceeded the benchmark value noted elsewhere in the deck and established the engineering justification to proceed with controlled fabrication and installation.

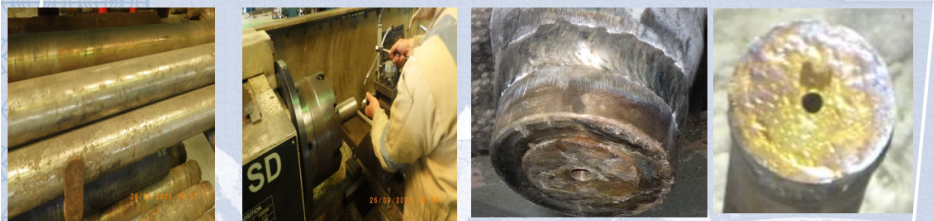
EKSEKUSI - FABRIKASI

The reconstruct the practical sequence of work: (1) identify and expose the failed tube zone, (2) cut the damaged section for preparation, (3) insert and weld the plug to stop flow on one side, (4) repeat the same action on the opposite side to fully isolate the failed tube from the system, and (5) install ceramic fiber insulation around the repaired area before restart.

Figure 4. Fabrication and field installation evidence from the project documentation.

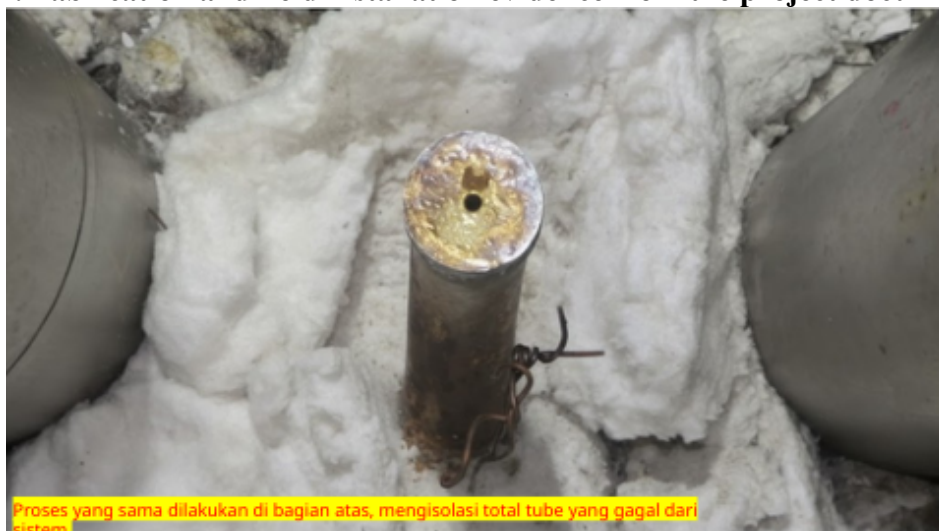
Figure 5. Example of the upper-side plugging condition after isolation of the failed tube.

The reported operating result after execution stated that the plugging arrangement sustained pressure up to 20.5 kg/cm² at reformer temperature reported in the deck as approximately 975°C. This indicates that the repair was not merely a temporary cold condition seal, but a hot-service isolation strategy intended to return the heater to service safely and rapidly.
